Docket No. 217 – Development and Management Plan Inspection

Date: October 12 and 13, 2005

Location: 115 kV Underground Route

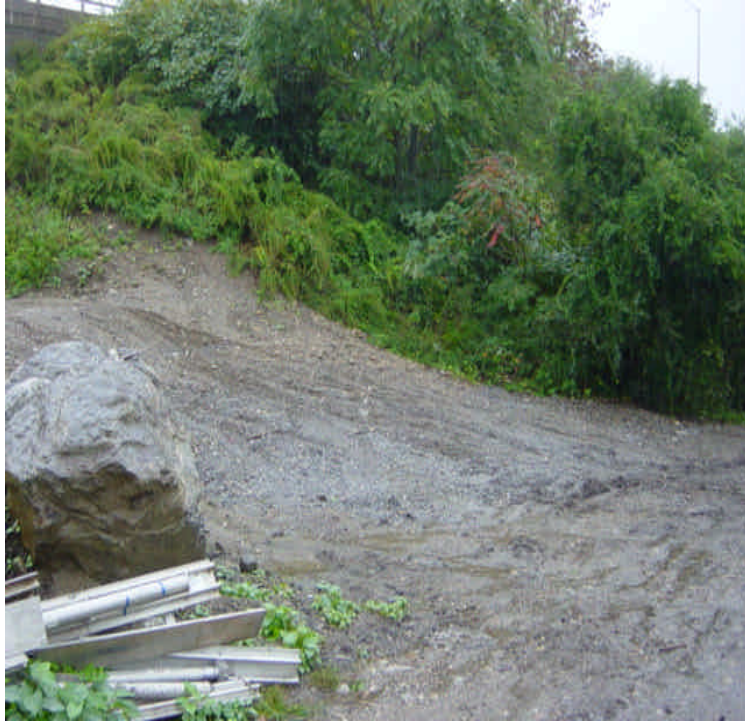
115kV (Broad Street and ROW): The photo on the left shows where the stockpile has been removed from the ROW. Photo on the right shows some excavation work near the Norwalk substation. Silt fence is well installed here. (10/13/05)

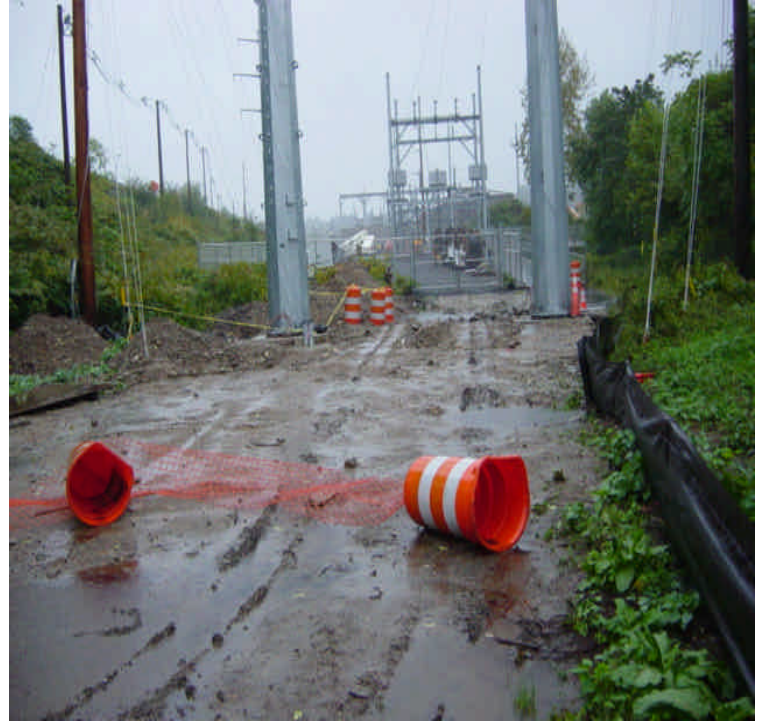
- The silt fence is well installed along most of the ROW including near the substation where excavation was occurring. 10/12/05	-Continue to maintain silt fence if needed. 10/12/05

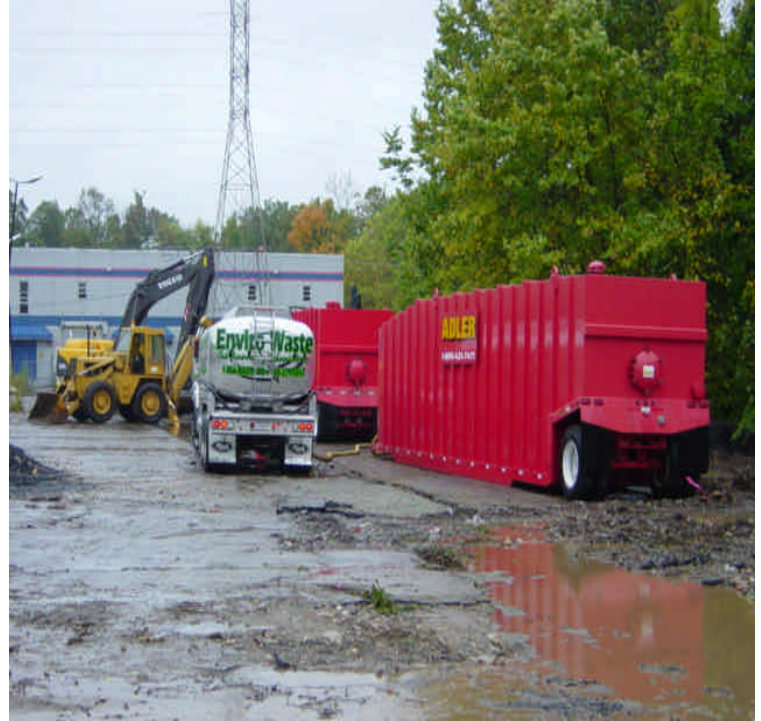
Areas of Inspection	Observation	Recommended Action
Dewatering	<ul style="list-style-type: none"> - Almost all dewatering discharge along the route is being directed to frac trucks or tanks due to concerns about the polluted soils. 7/21-10/12/05 - Larger volumes of water at the Norwalk Junction foundation installation required the use of a frac truck. The water was later discharged here (unapproved) and a sheen was noted in some areas as a result. Water testing and environmental cleanup occurred here as a result. This had occurred prior to the inspection 10/12/05 	<ul style="list-style-type: none"> - It appears that the storage and disposal solution will continue due to concerns about the background pollutants in soils, even in those not considered contaminated. 7/21-10/12/05 - Tests came back normal and EPA was notified. The area was cleaned up by the time of inspection. 10/12/05
Blasting	<ul style="list-style-type: none"> - No blasting is occurring in any areas at this time. 	<ul style="list-style-type: none"> - None at this time.

115kV (Route 7): Photo on the left shows catch basin controls near the jack and bore on Broad Street. Photo on the right shows the Norwalk Junction transition station where some water sampling was ongoing following a reported emptying of a frac tank that had been used for dewatering. (10/13/05)

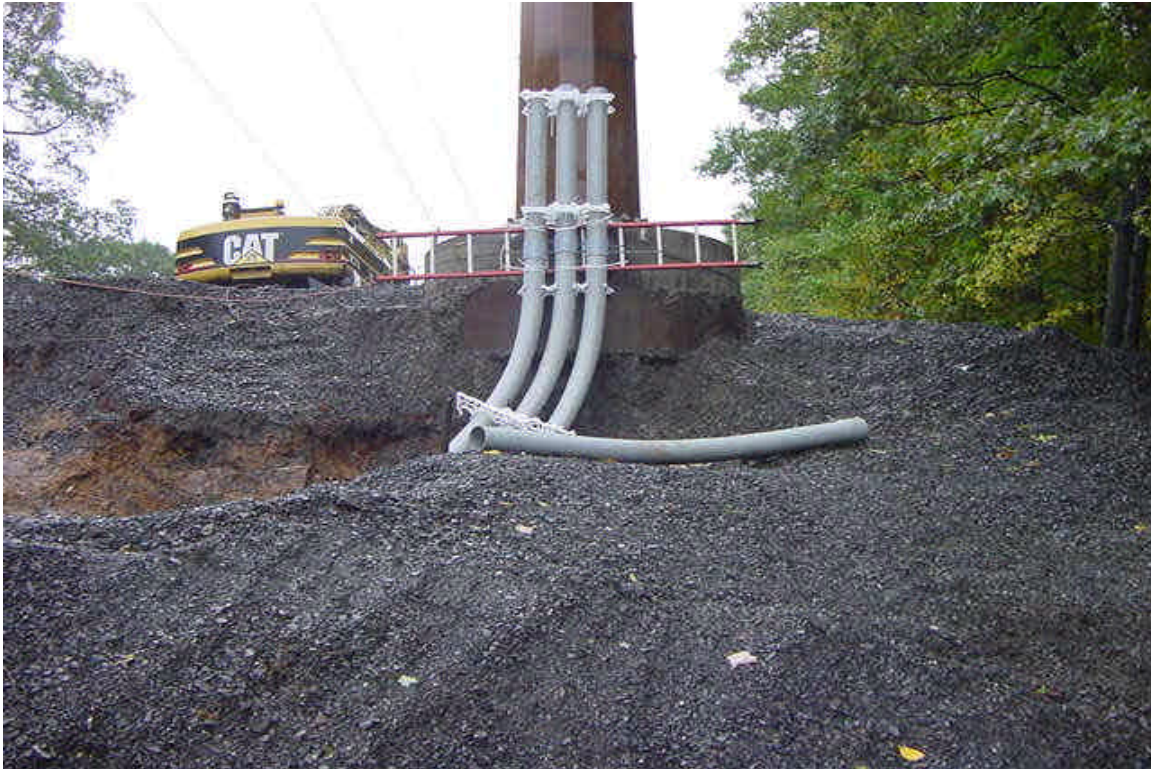
115kV (Gallows Hill Rd. and the ROW): Conduit is being installed up to the riser transition structure on the ROW from Gallows Hill. (10/12/05)

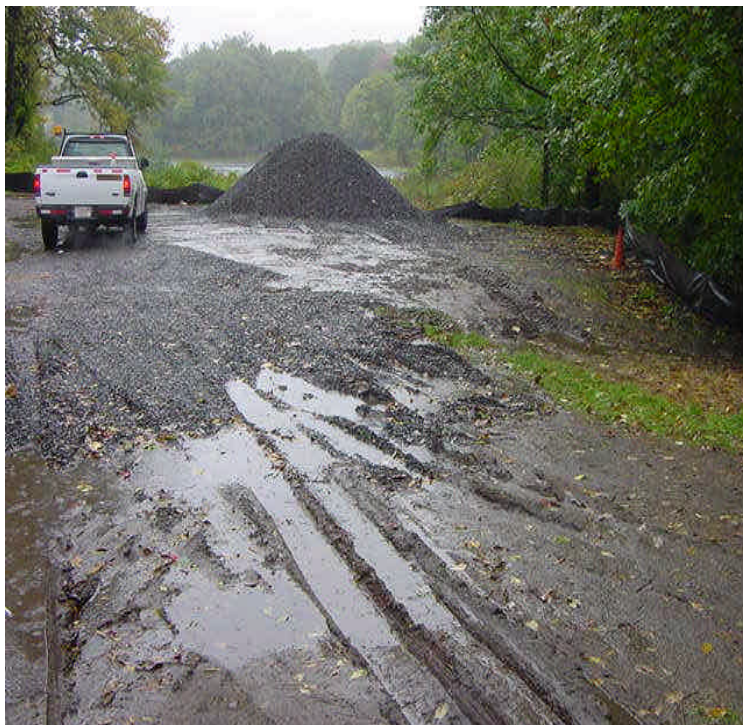
115kV (Route 58): Photo on the left shows the Putnam Park storage area where a process stone pile is placed. Silt fence behind the pile needs to be repaired. Photo on the right shows the Sunset Hill Rd. storage area where similar stone is piled. (10/12/05)

Rt. 107 (Lonetown Rd)	- Work will need to return to the state Rts. to bring them to specified grade. Silt fence should remain and be maintained before work returns. Otherwise silt fence can be pulled and then reinstalled. 9/29-10/12/05 - Silt fence repairs were needed at both storage areas. 10/12/05 - Active work was noted near Lois Lane. The bank cut area here should be restored when work is complete. 10/5-10/12/05	-Maintain controls when work returns to the area. 10/12/05 - See Storage section. - None at this time but restore when work is complete. 10/5-10/12/05
Broad Street and ROW, Norwalk	- The soil stockpile and debris pile in the ROW just off Broad St. was removed. 10/12/05	-None at this time. 10/12/05

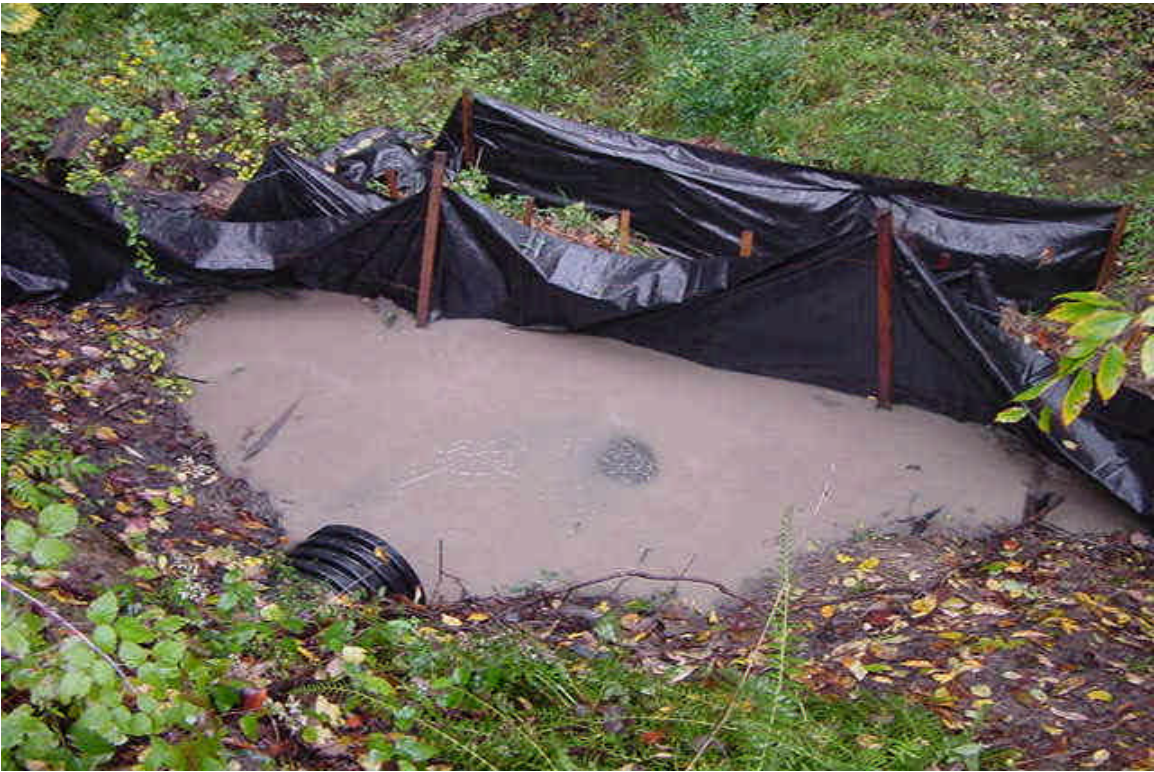
Areas of Inspection	Observation	Recommended Action
	<p>- In Redding Town Yard, soil excavate is only temporarily stored here until it can be trucked for disposal in the O&G facility in Bridgeport or the Redding landfill.</p> <p>The additional controls installed at the Redding Yard continue to be effective in retaining the concrete washout water. Heavy flow from the outlet was observed being contained for the most part. 10/12/05</p> <p>- At the storage area off Rt. 58 near the Putnam Park entrance, a new process stone stockpile was in place but silt fence was down near the pond. 10/12/05</p> <p>- The silt fence at the yard at the intersection of Rt. 58 and Sunset Hill Rd had been flattened by trench boxes again but remains somewhat in working order. 10/12/05</p> <p>- Both of the Redding CC storage areas fences by the country club and before the turn need some repairs. 10/12/05</p>	<p>- None at this time, continue to maintain the controls as needed. 10/12/05</p> <p>-Silt fence needs restoration and monitoring here. 10/12/05</p> <p>- Continue to maintain fence and treat it as a limit of work. Vehicles should stay within the fenced areas. 10/12/05</p> <p>-None at this time. 10/12/05</p>

115kV: (Redding Storage Yard) Shows the controls at the discharge pipe working well to contain runoff from the yard during heavy rain. (10/12/05)

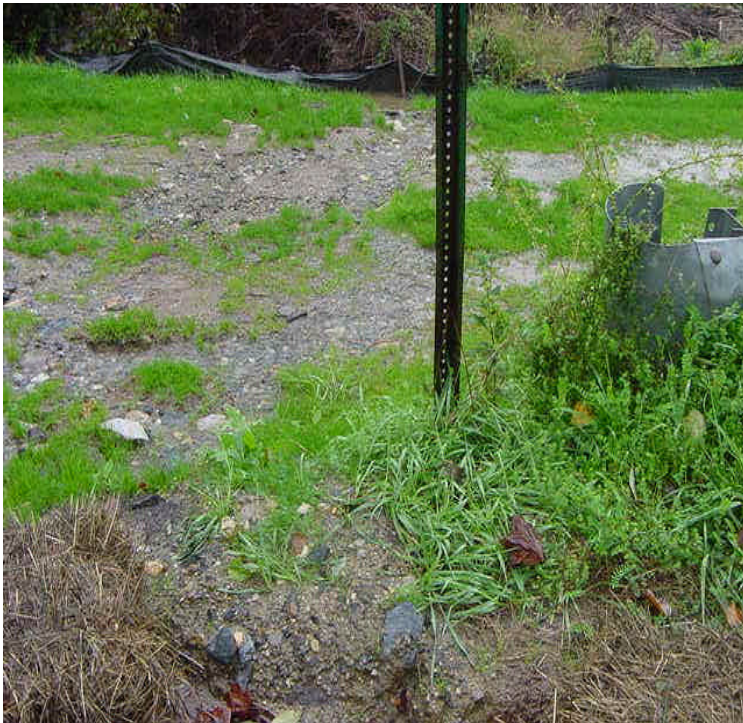
<ul style="list-style-type: none"> - All disturbed areas continue to show very good grass growth including edge areas along the ROW. 9/29-10/12/05 - The gully noted on the northern part of the ROW continues to be repaired but washed out. 10/12/05 - Excavations were backfilled and silt fence was in good shape in all locations. 10/12/05 	<ul style="list-style-type: none"> - None at this time. 10/12/05 - Haybales were placed to deflect water but the heavy rains were overwhelming. 10/12/05 - None at this time. 10/12/05
Hoyts Hill Riser Termination Structure (Off Rt. 58)	<ul style="list-style-type: none"> - Erosion controls are in good shape here and the excavation for grounding is complete. 10/12/05 - The contractor has removed the homeowner's wood debris pile as requested by the siting council. 10/12/05 	<ul style="list-style-type: none"> - Keep all areas of erosion control maintained until the area can be restored. 10/12/05 - None at this time. 10/12/05

115kV: (Bethel Educational Park). Photo on the left shows the gully area that keeps washing out on the northern ROW. Photo on the right shows an overview of the southern ROW. 10/12/05
